NRC Medium Voltage Circuit Breaker Training

CHAPTER 7

**INTRODUCTION TO
WESTINGHOUSE DHP CIRCUIT
BREAKERS**

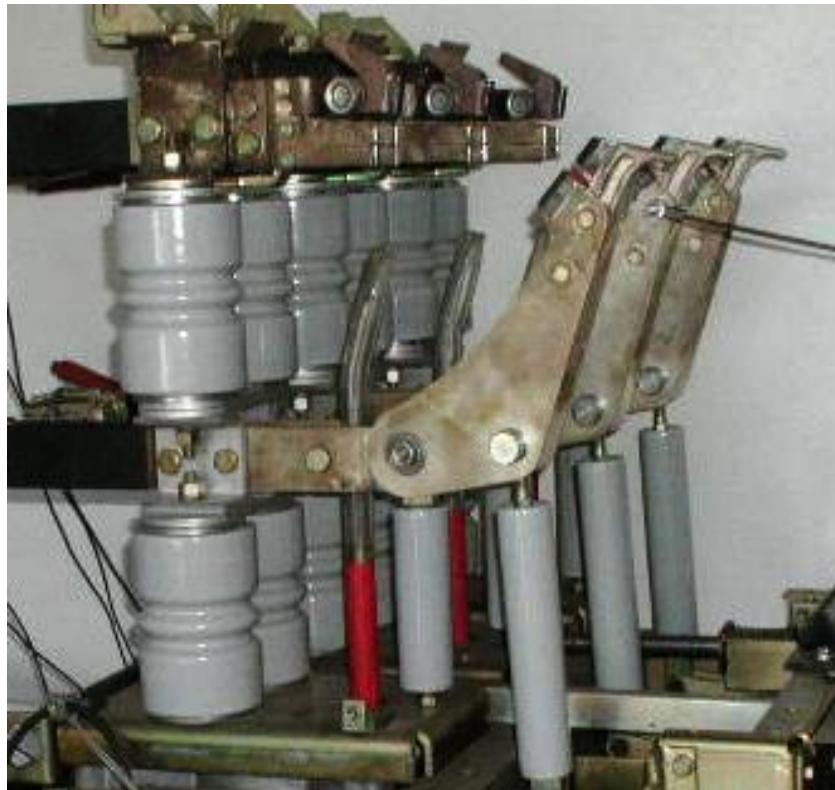
Pole Unit Bases Insulators

There were two versions of primary insulators used on DHP's

- Monolithic -Original insulator type
- Post Insulated Pole (PIP) – Newer design

- Post Insulated Pole (PIP)

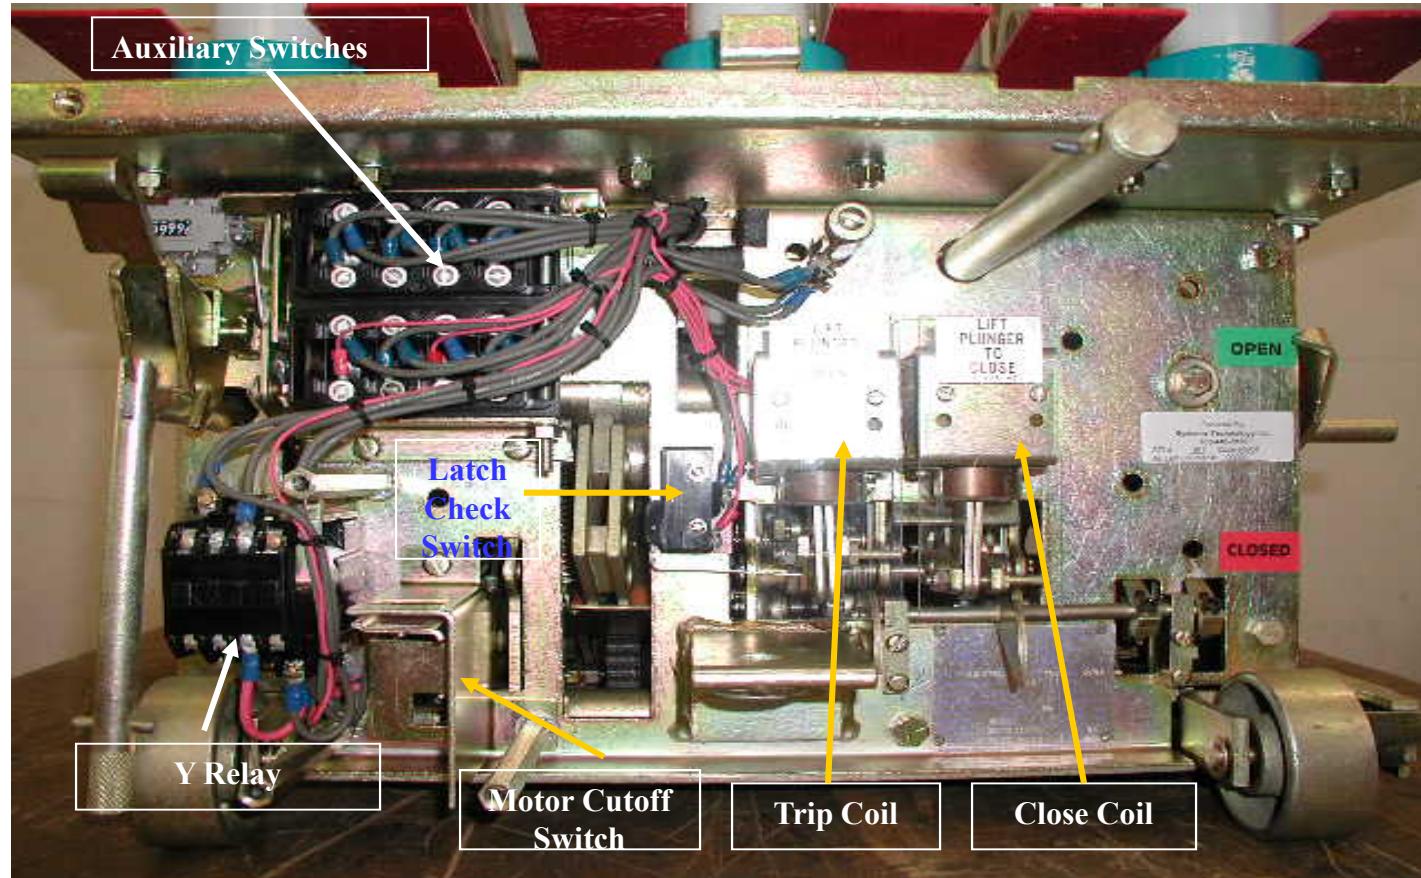
Front Plate

The following components are mounted on the front panel

- Auxiliary Switches
- Spring Release and Shunt Trip Coil
- Control Relay
- Motor Cutoff Switch
- Latch Check Switch
- Resistor
